How to Reset Toyota Clearing Yaw Rate Acceleration Sensor and VSC Light

TOYOTA Engineer Li Yongshuai

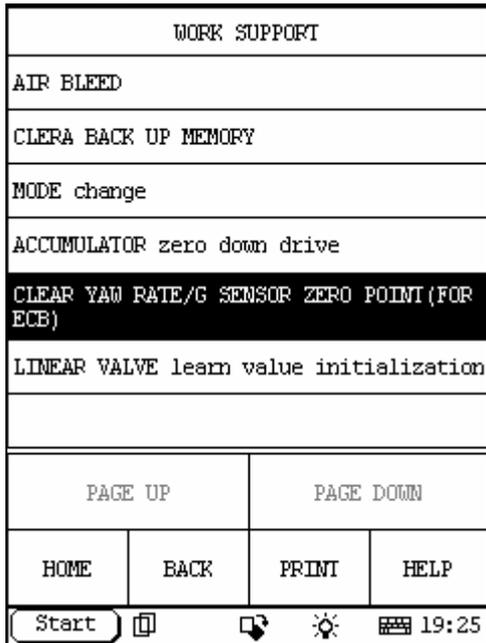
Fig.1

After entering ABS menu, select "clearing yaw ratio/acceleration sensor zero point (to ECB), and then the screen will prompt a dialog box. See fig.1 and fig.2.

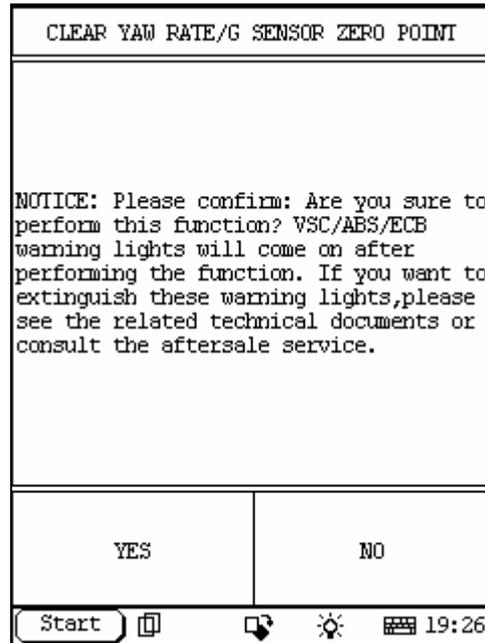
Fig.2

In fig.2, it will prompt that if you want to execute the function, the warning light will be light, and how to extinguish the light. Click [YES] to continue.

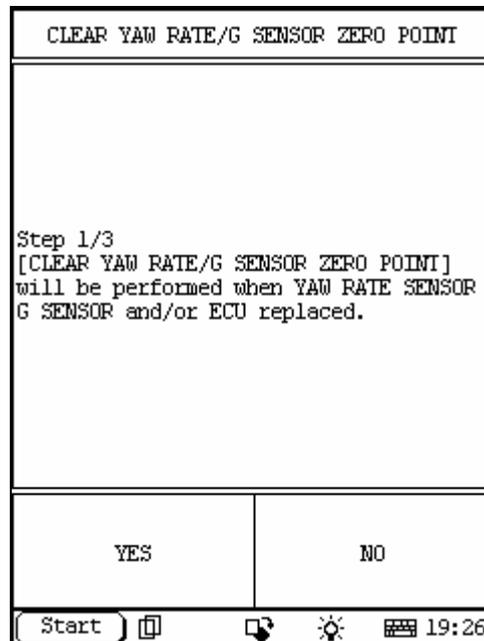
Fig.3

Then enter the function menu, there are 3 steps to do, and there are prompts for relative conditions and status for every step. Please follow the instructions. See fig.3, fig.4 and fig.5.

Note: please operate with ignition switch ON and in P position.

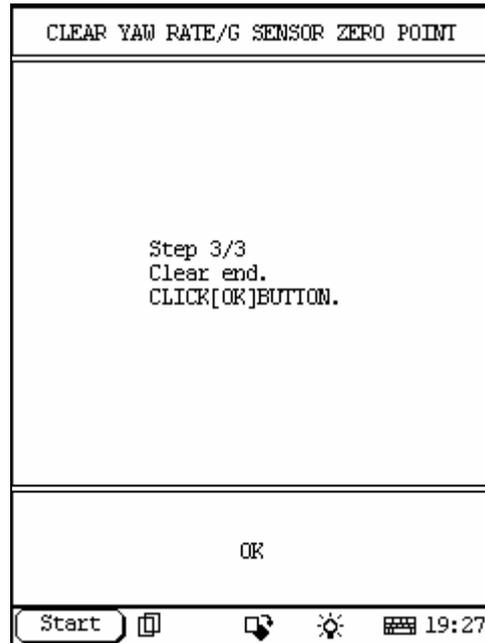
Fig.5

Note: VSC/ABS warning light will be light after doing this operation. The light can't be cleared by clearing DTC function. The DTC is C1336-yaw sensor is being reset.

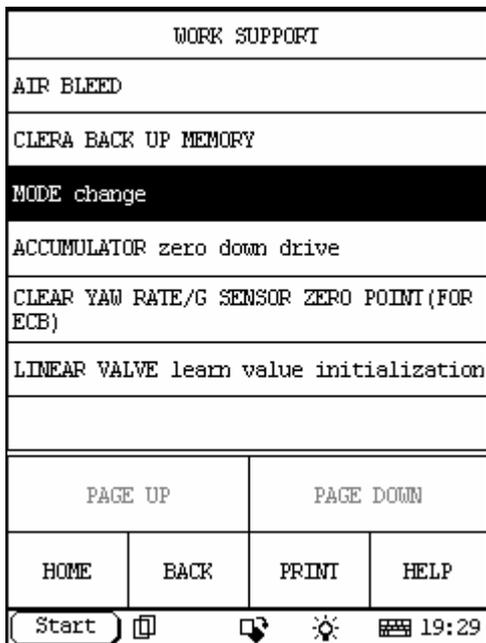
Fig.6

1. Turn ignition key ON when warning light is lit.
2. Turn ignition switch ON and enter the WORKING SUPPORT menu of ABS.
3. Under MODE CHANGE menu, make it in check mode.

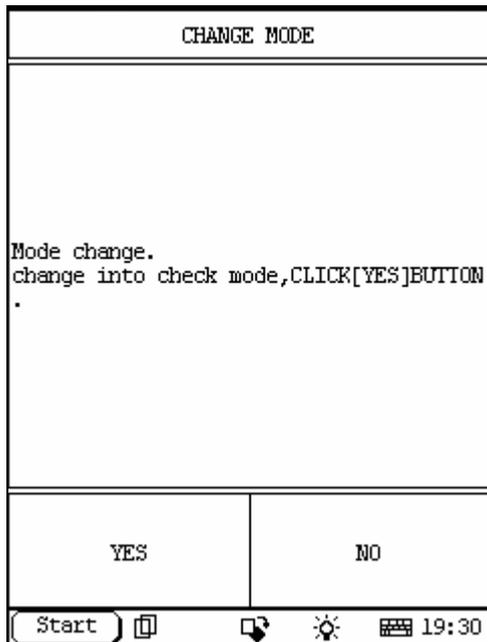
Fig.8

Select NO to enter check mode menu. See fig.8. Click [YES] to enter check mode. See fig. 9.

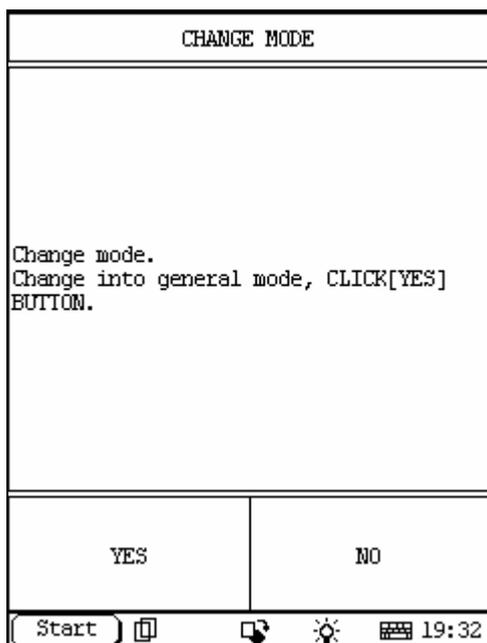
Fig.10

Click "OK" in fig.9, [YES] in fig. 10, then it will enter normal mode. See fig. 11.
